SYMPTOM & SCOPE OF WORK

Inadequate bearing lubrication has been identified on a small number of TG600RS & TG900RS models causing reduced longevity or possible bearing collapse. TopGun Mobility takes the Reliability & Longevity of our scooters very seriously and have provided the below guide detailing how to access the Right Hand Side Rear wheel bearing, for greasing

Dealer Service Bulletin # DSB118
PRIORITY MAINTENANCE – Transaxle Bearings
Model : TG600RS & TG900RS

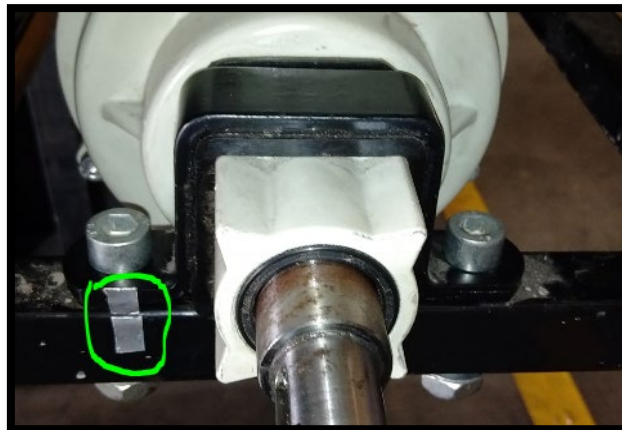
Fig i)

1. With the scooter supported, remove the rear wheels and mark the left (fig i) & right (fig ii) axle clamps position on the frame. This will ensure that rear wheel alignment will be the same after the job.

Silver tape was used below, but white-out will work well.

*** Please take care to align the transaxle with the marks that were made, this will ensure good wheel alignment.

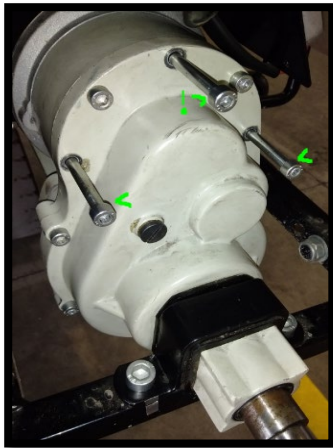
Fig iii)

2. Loosen the 3 bolts highlight (Motor Attach bolts, fig iii) remove the two lower bolts and leave the upper one screwed in until ready to take the weight of the motor unit. Disconnect the motor and brake unit wiring (see fig iv). When ready to remove motor, remove the last (upper) of the 3 bolts in fig iii. Note – Do not remove brake unit.

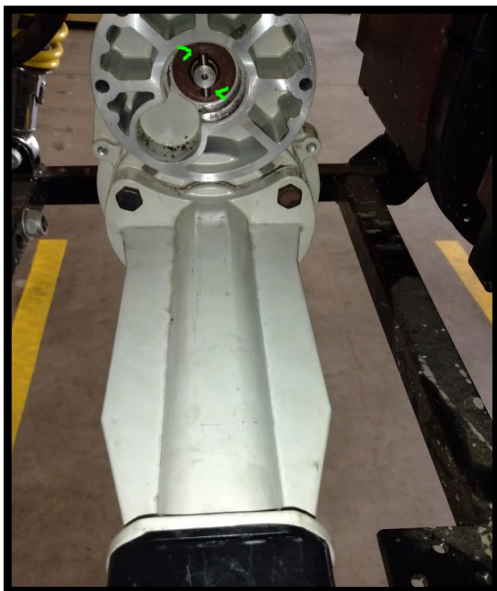
Fig v)

Fig v shows the transaxle with motor removed via RHS of scooter, Please note position of coupler pin as this will aid with motor re-installation.

The coupler pin can slide around, it must be centered.

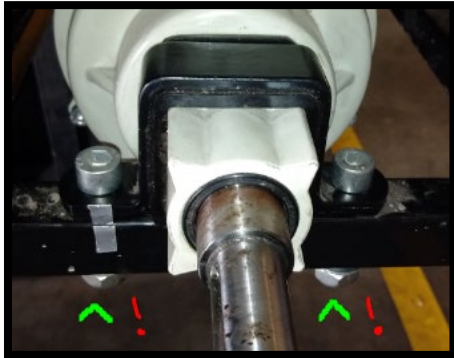
Fig vi)

Loosen but don't remove the nyloc nuts on the LHS axle clamp bolts (fig vi) loosening until the nut is level with the end of each bolt. Remove the RHS axle clamp bolts as shown in fig vii

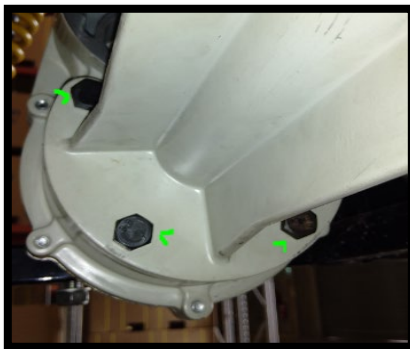
Fig viii)

Remove the four bolts (fig viii & ix) and slide the extension housing off it's shaft carefully via RHS of scooter. Tilt the RHS of the transaxle upwards slightly to aid removal. This can be done as the LHS axle clamp bolts were loosened but not removed.

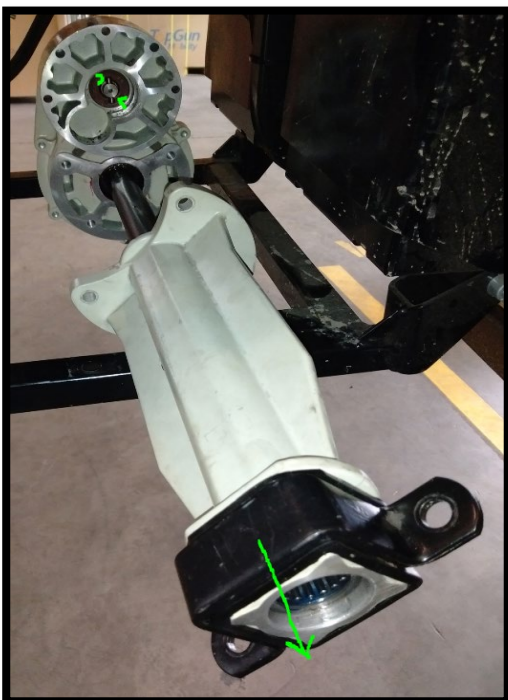
Figure x shows the extension housing being withdrawn via the RHS of the scooter.
Fig x

Take care not to strike/ bump the inside of the housing or bearing on the driveshaft as it is withdrawn, as this will damage the bearing.

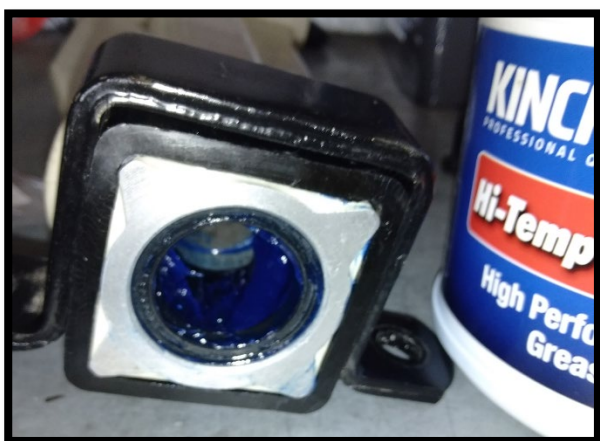
Fig xi)

3. Before packing bearing with grease, please visually inspect the bearing for any sharp protrusions, use a glove to apply a liberal amount of grease and massage into the rollers & race as in fig xi. The bearing should very smooth. Also apply grease to the bearing journal surface of the RHS axle as shown as in fig xii.

** The grease used must be a High Temperature Bearing Grease.

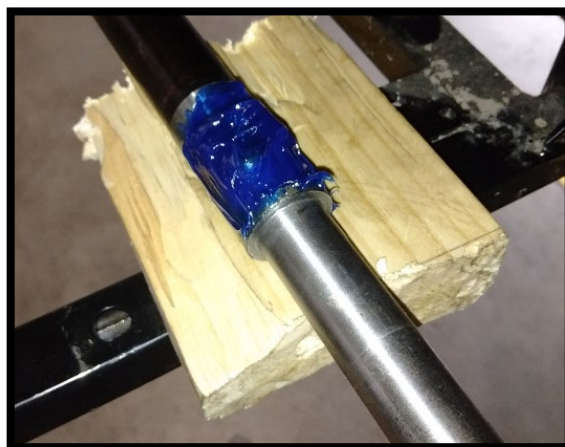
Fig xii)

RHS Axle shown supported by a wooden block which also prevents dirt ingress.
