# Dealer Service Bulletin #DSB140

## LiON - Loose flange causing power failure & connector damage

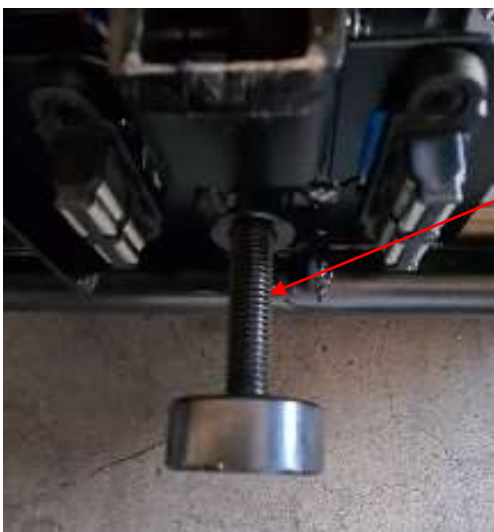
Apply bonding agent here

Refit the bolt with flange to motor body and again apply a bonding agent such as Loctite 263 to the threaded shaft of the bolt before finger tightening into place

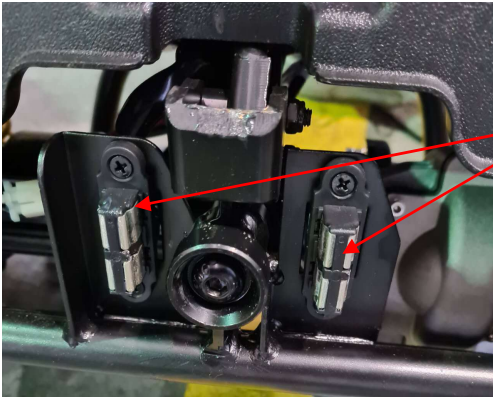
Male Connectors - Inspect

Please then inspect male and female connectors to ensure they have not been damaged from excessive freeplay
